Manhole Inspection Summary

Manhole # S33UU_004MH

Location Address: **2890 HOWARD ST**

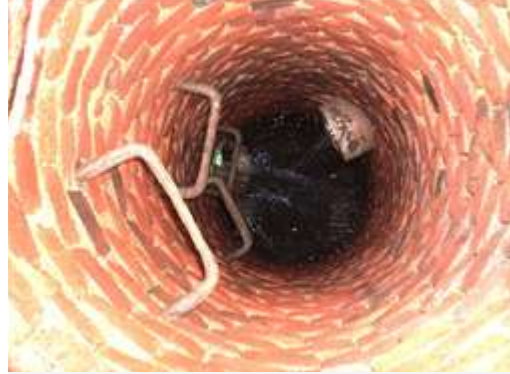
Top View

Corroded steps. Bench debris.

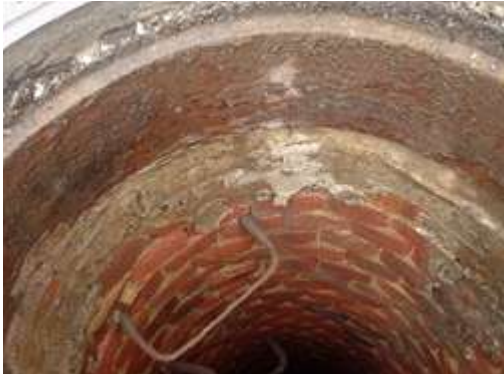
Defect

Frame leaks. Adjustment and Corbel deterioration and infiltration - other side.

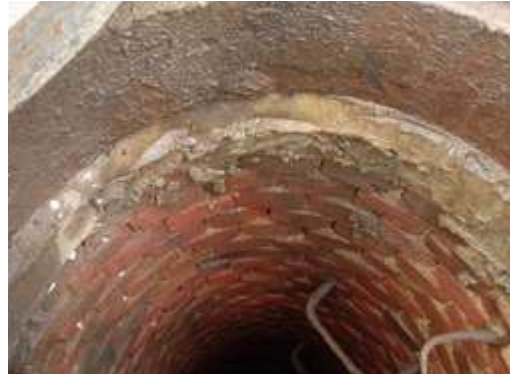
Defect

Frame leaks. Adjustment and Corbel deterioration and infiltration.

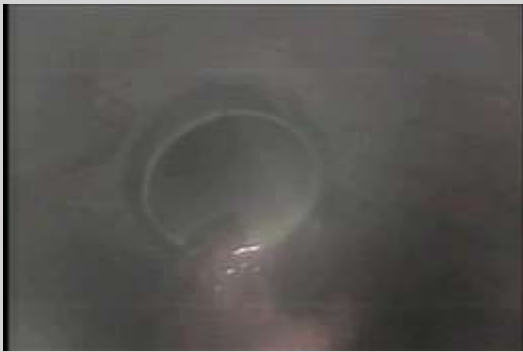
Pipe In @ 9 O'Clock

Infiltration: **Evidence** Pipe Seal Cond: **Unknown**
